**RE: Summary Report of Preliminary Site Investigation Activities
Weld County, Colorado**

This letter report summarizes the site investigation field activities recently performed by Tetra Tech at the Pratt Property in Weld County, Colorado (the Property). A summary of the proposed scope of the site investigation activities is listed below:

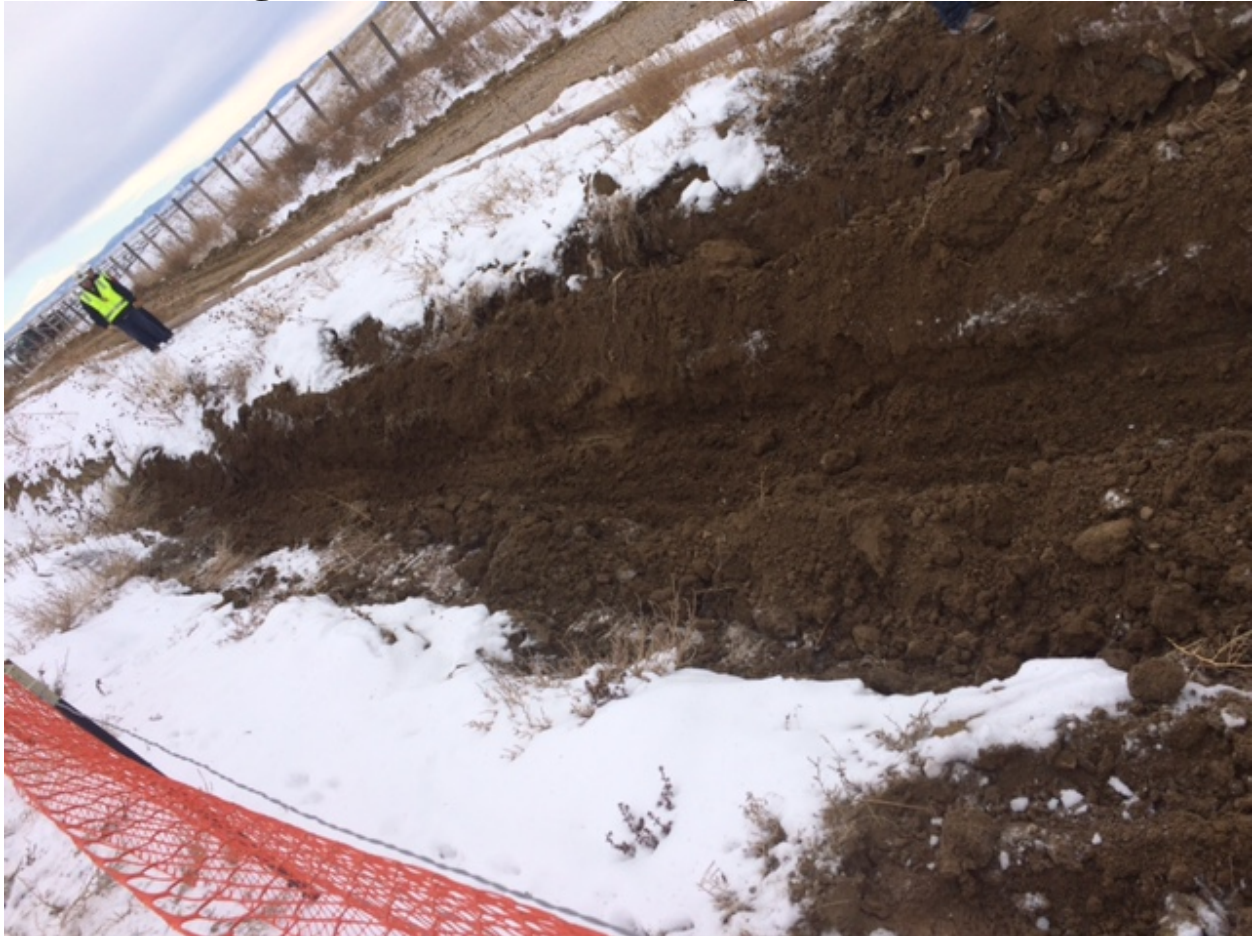
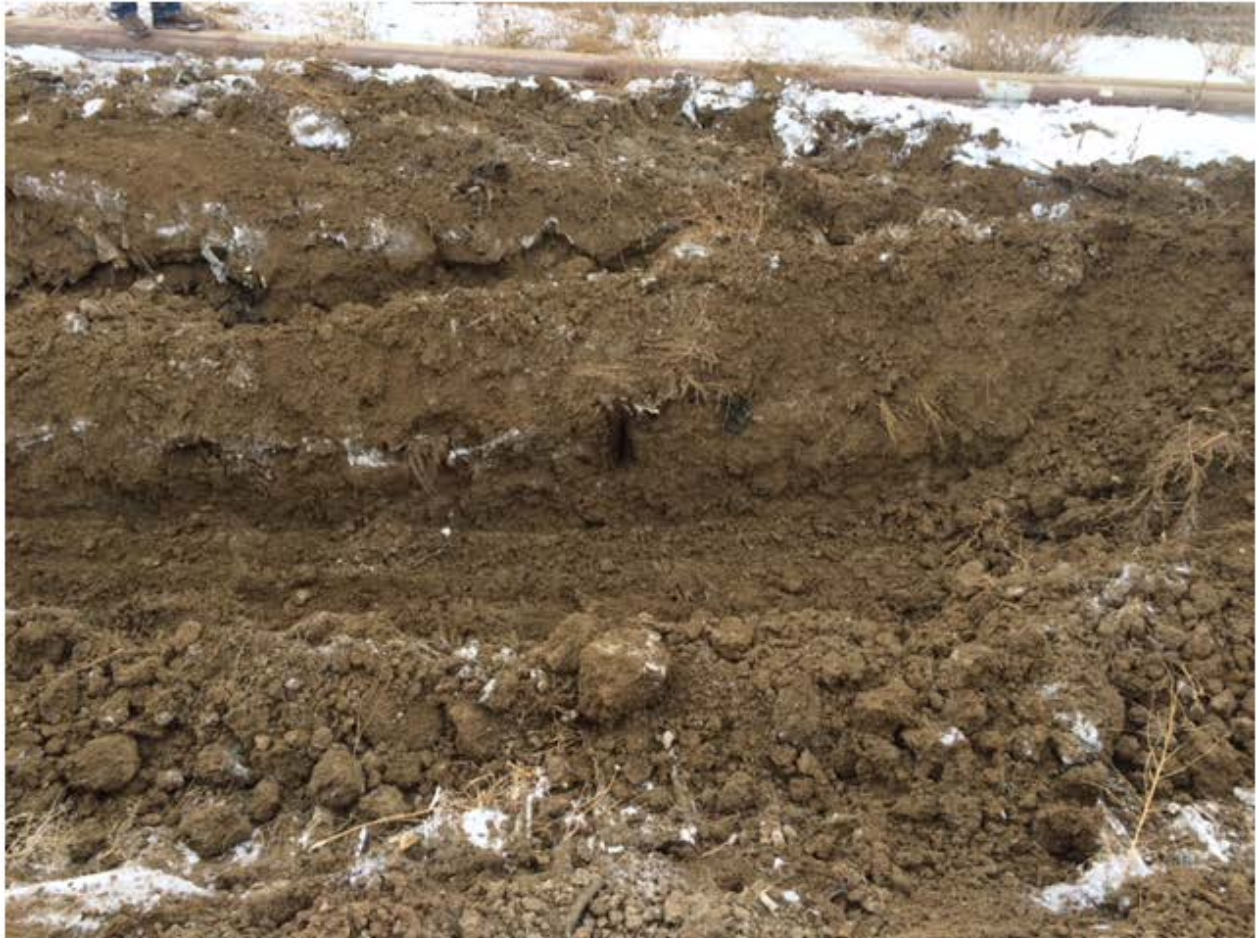
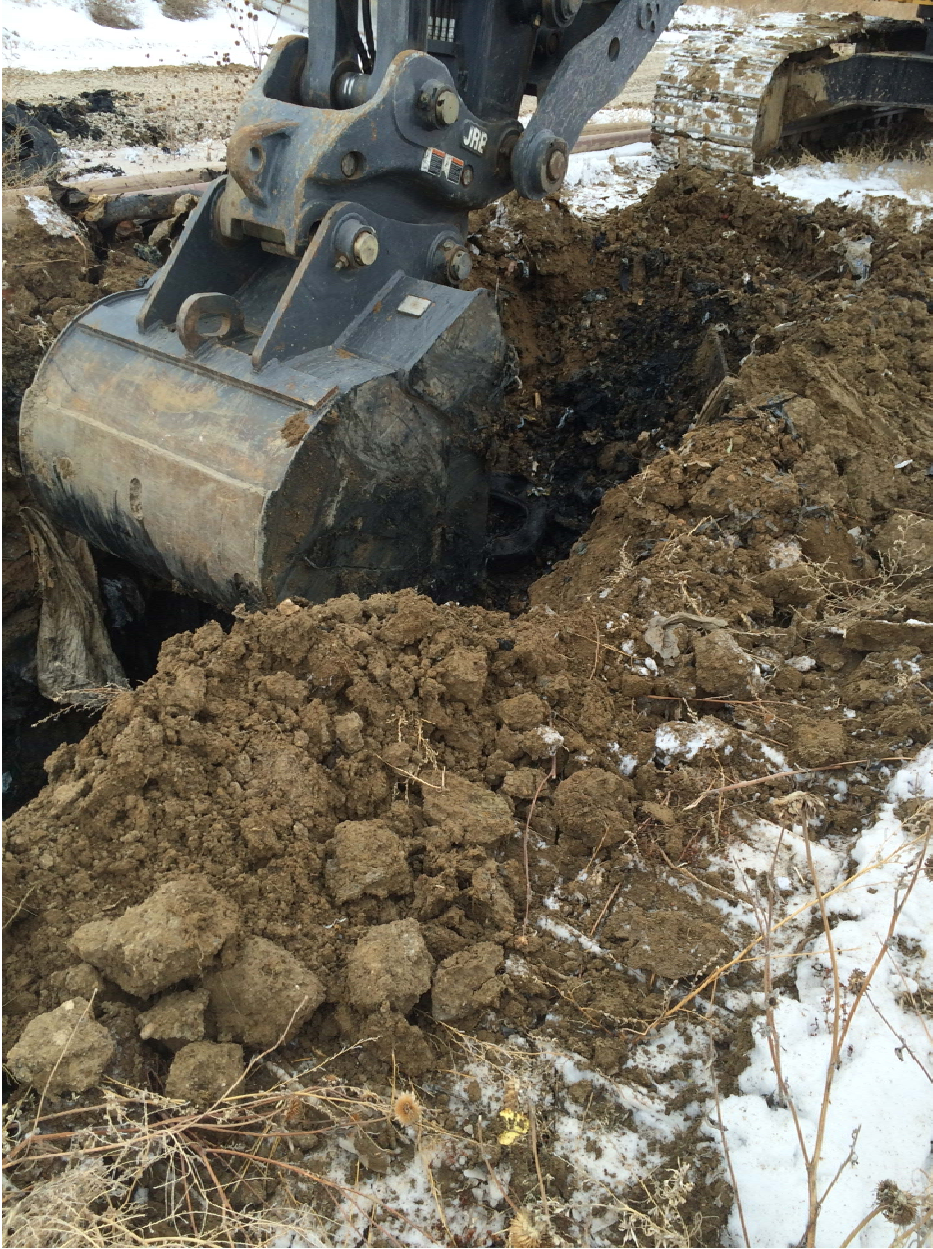
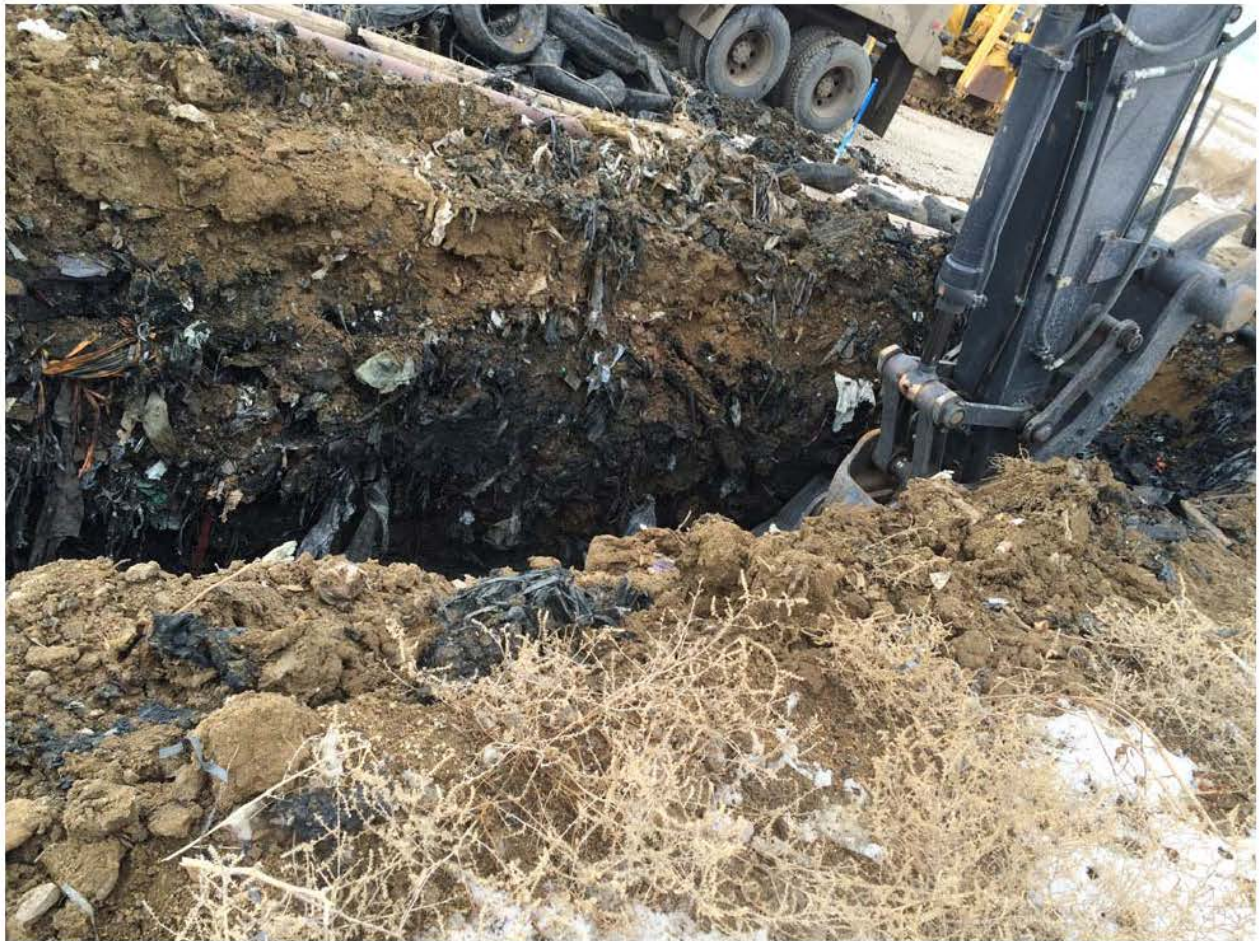
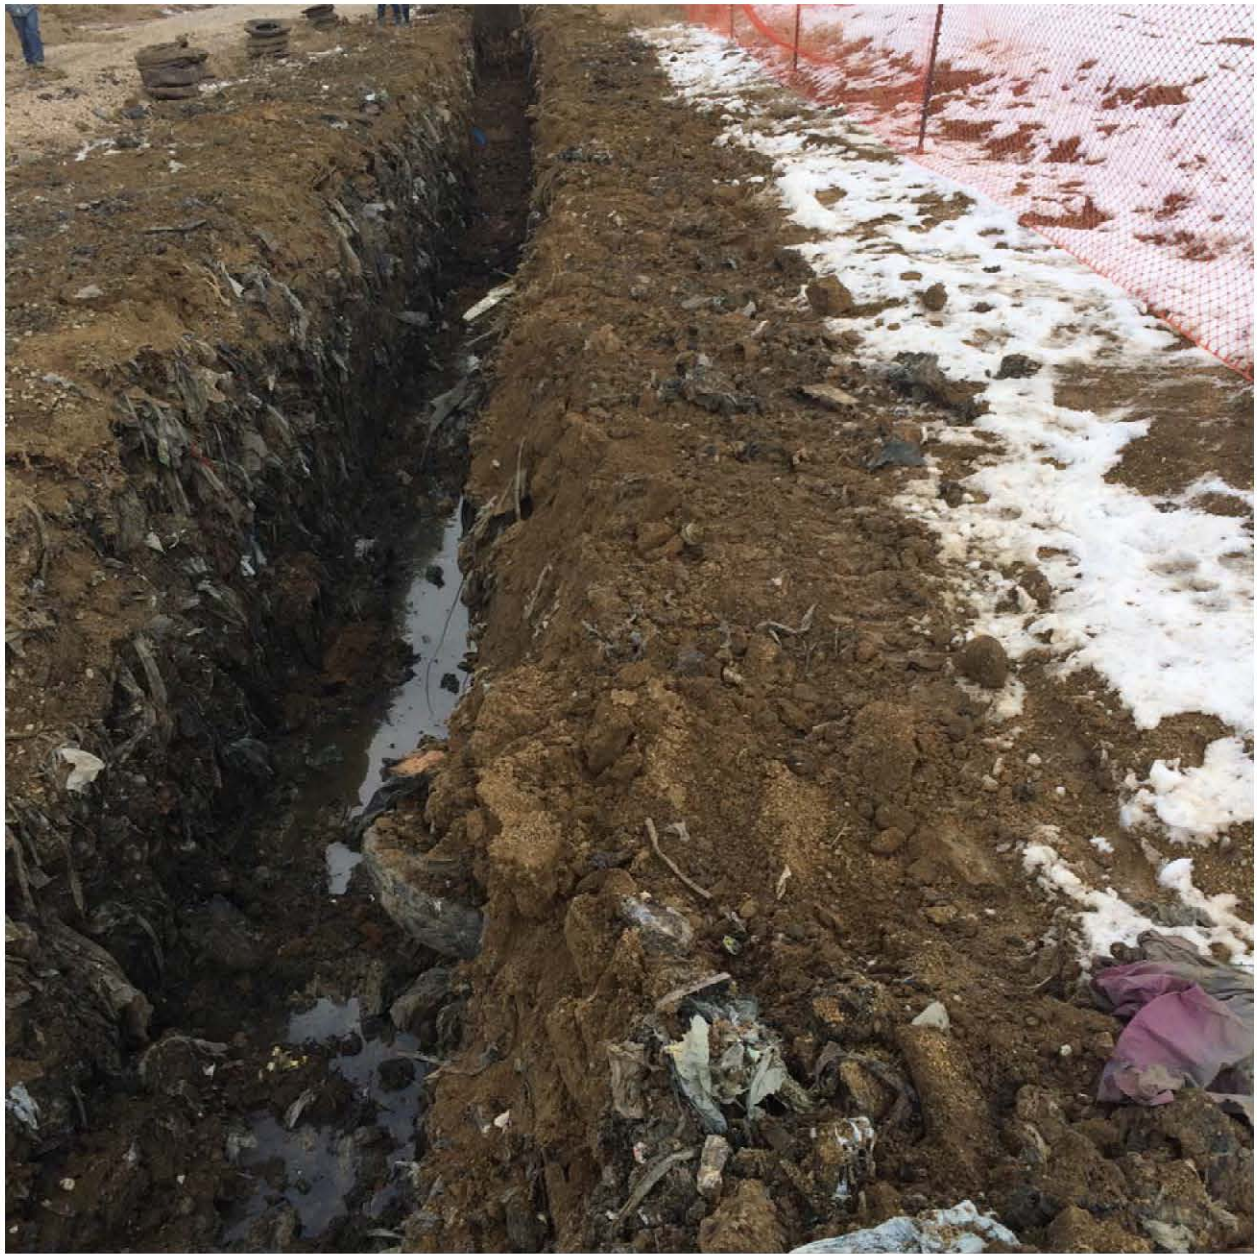
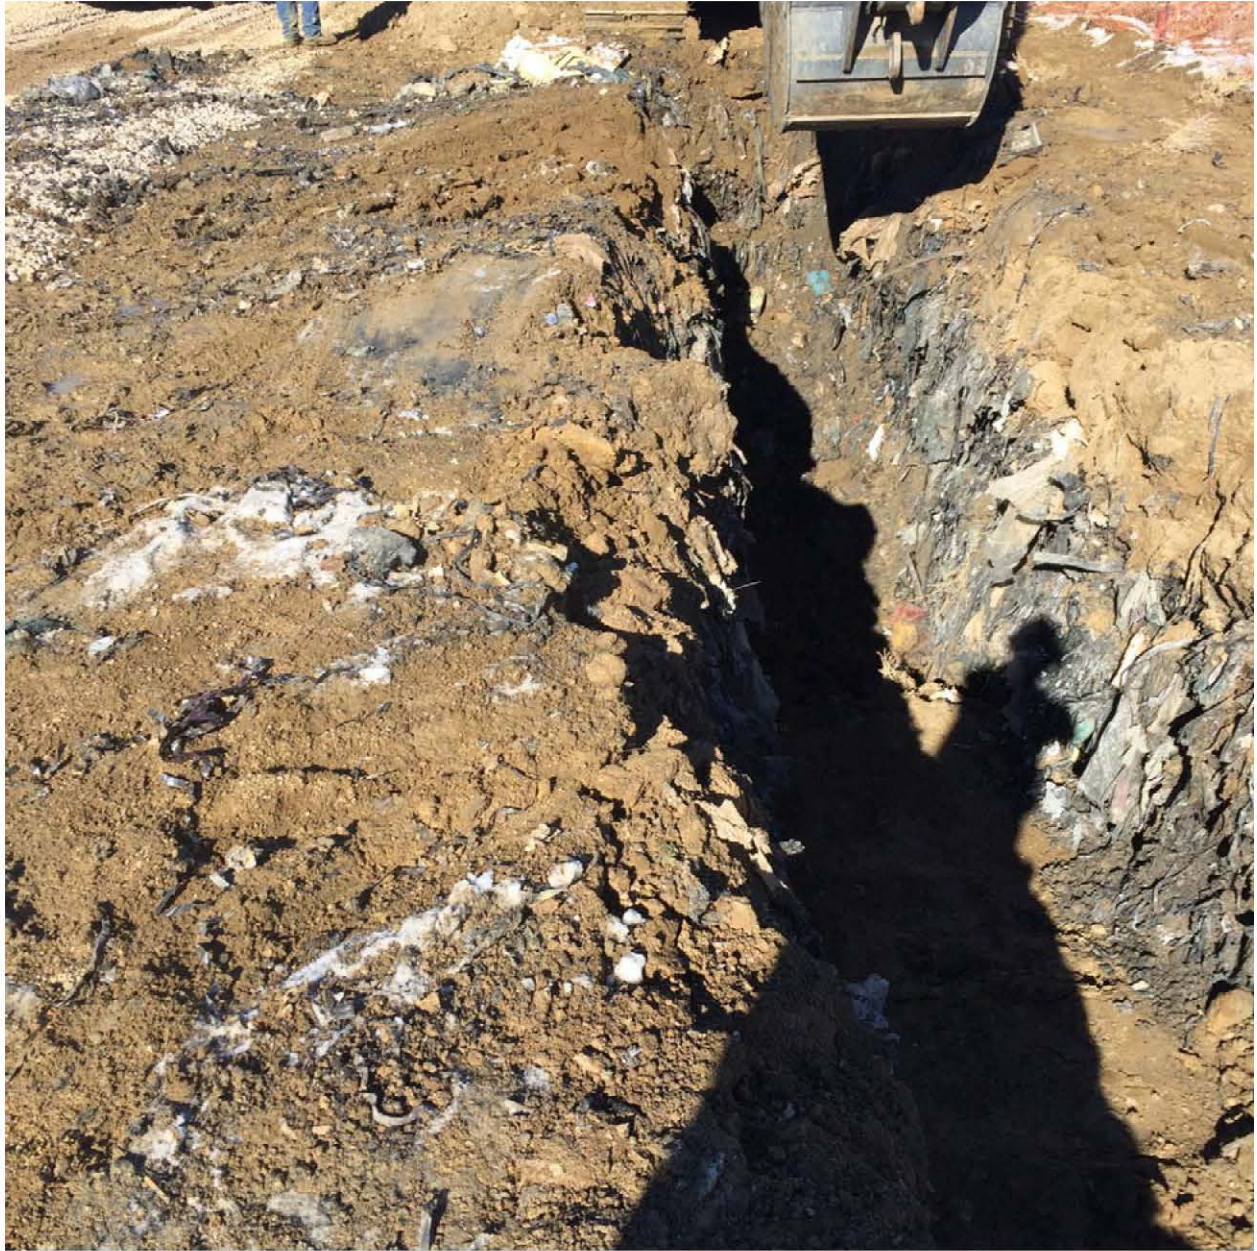
ROW during trash removal and disposal

The buried trash excavation project and pipeline installation at the Pratt Property began on November 30, 2015 and was completed on December 11, 2015. A total of 80 loads of materials primarily trash and soils were removed from the ROW and transported to the Front Range Landfill for disposal. The weather was good every day, and wind speeds were low so blowing trash was not an issue. The ground conditions were impacted by melting snow cover which moistened the soils, keeping dust conditions nonexistent.

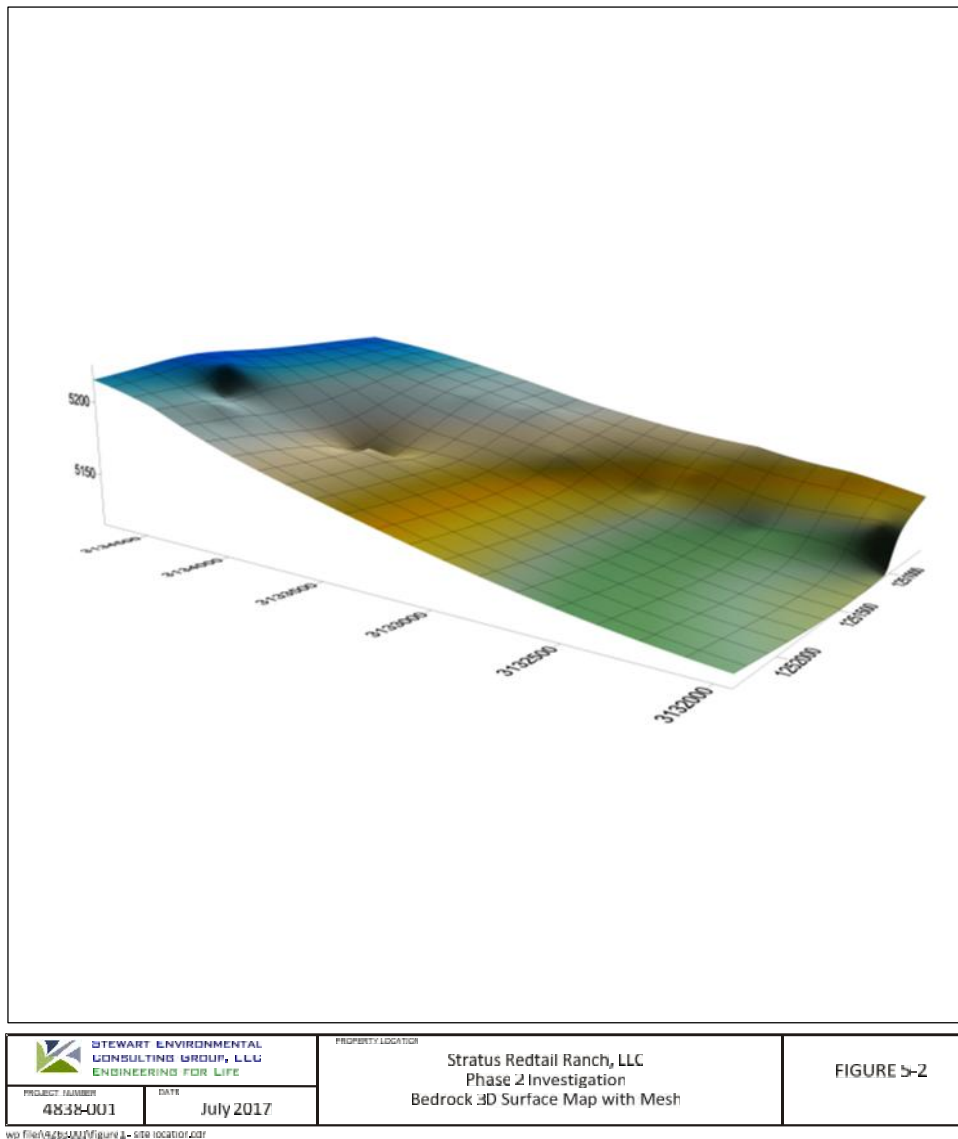
We also developed a 3D model of the bedrock to allow for different views of the site. A 3D view is provided in Figure 5-2 and the model which can be manipulated is found on the Stratus – CDPHE drop box.

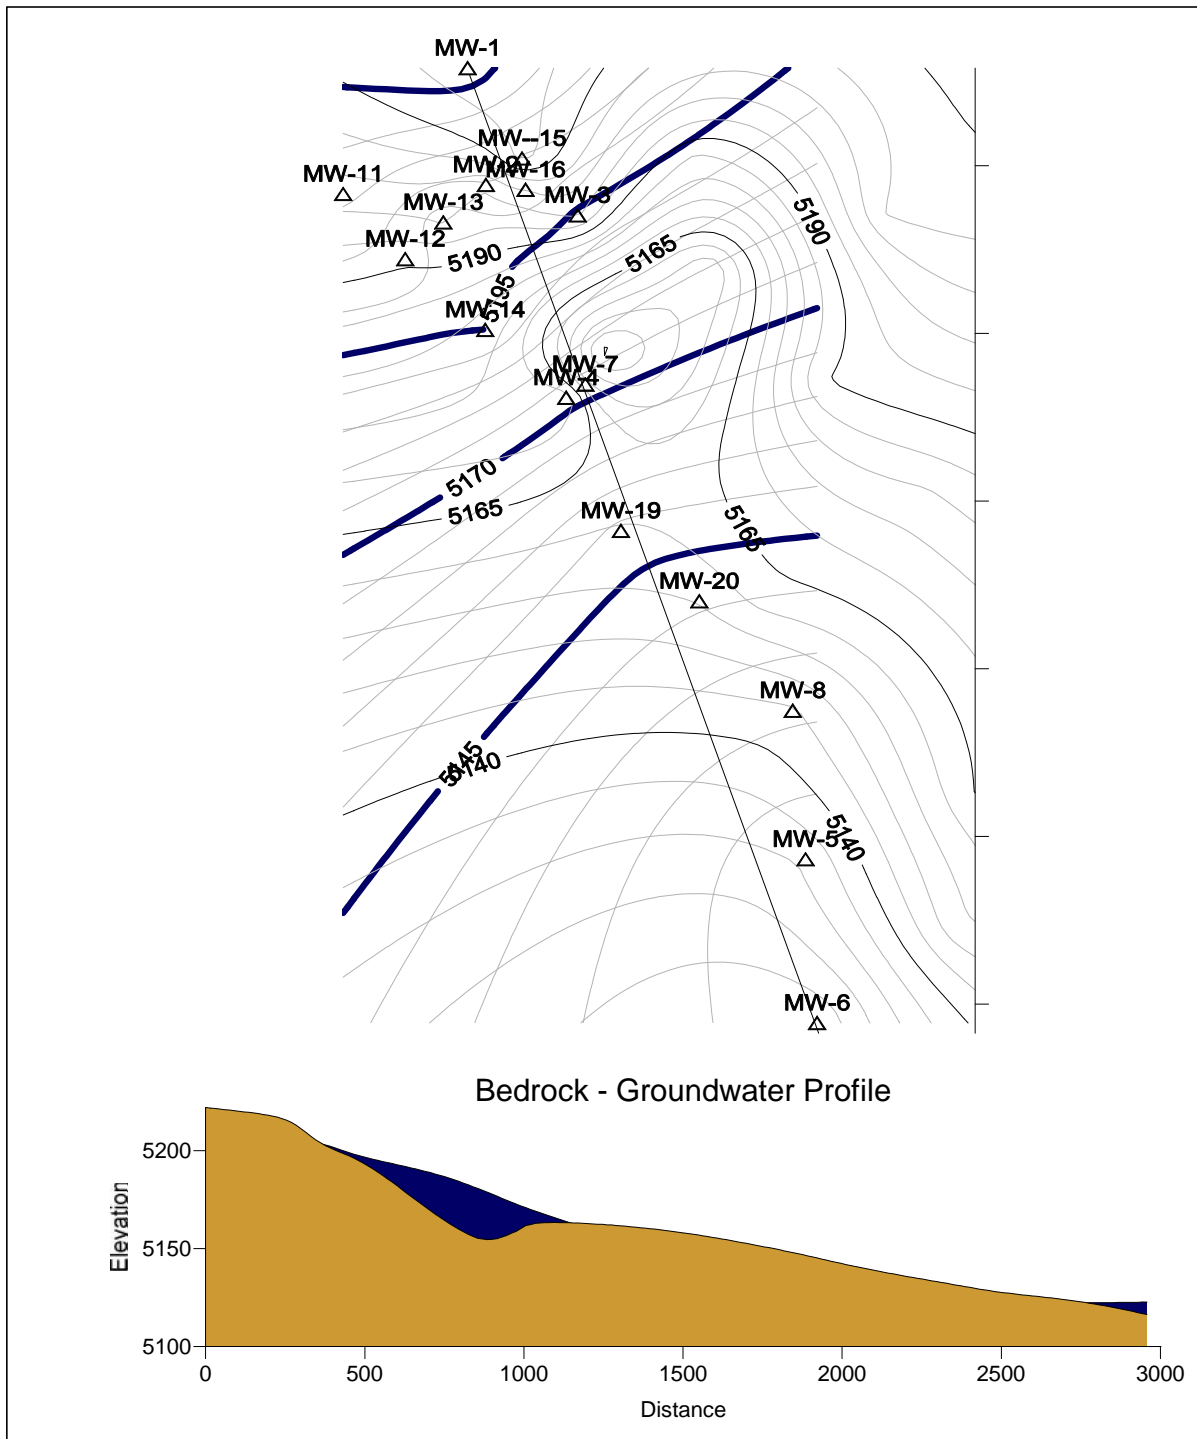
STEWART ENVIRONMENTAL CONSULTING GROUP, LLC ENGINEERING FOR LIFE		PROPERTY LOCATION Stratus Redtail Ranch, LLC Phase 2 Investigation Bedrock – Groundwater Interaction	FIGURE 5-3
PROJECT NUMBER 4838-001	DATE July 2017

The bedrock and shallow groundwater interaction is provided in Figure 5-3. As shown in this figure, the groundwater would need to surface prior to reaching the top of the bedrock on the south side of the site.
